FINAL REPORT
JANUARY 1998

REPORT NO. 98-06

EUROPALLET TESTING
AND EVALUATION
STANAG 2828 AND
MIL-STD-1660 TESTS

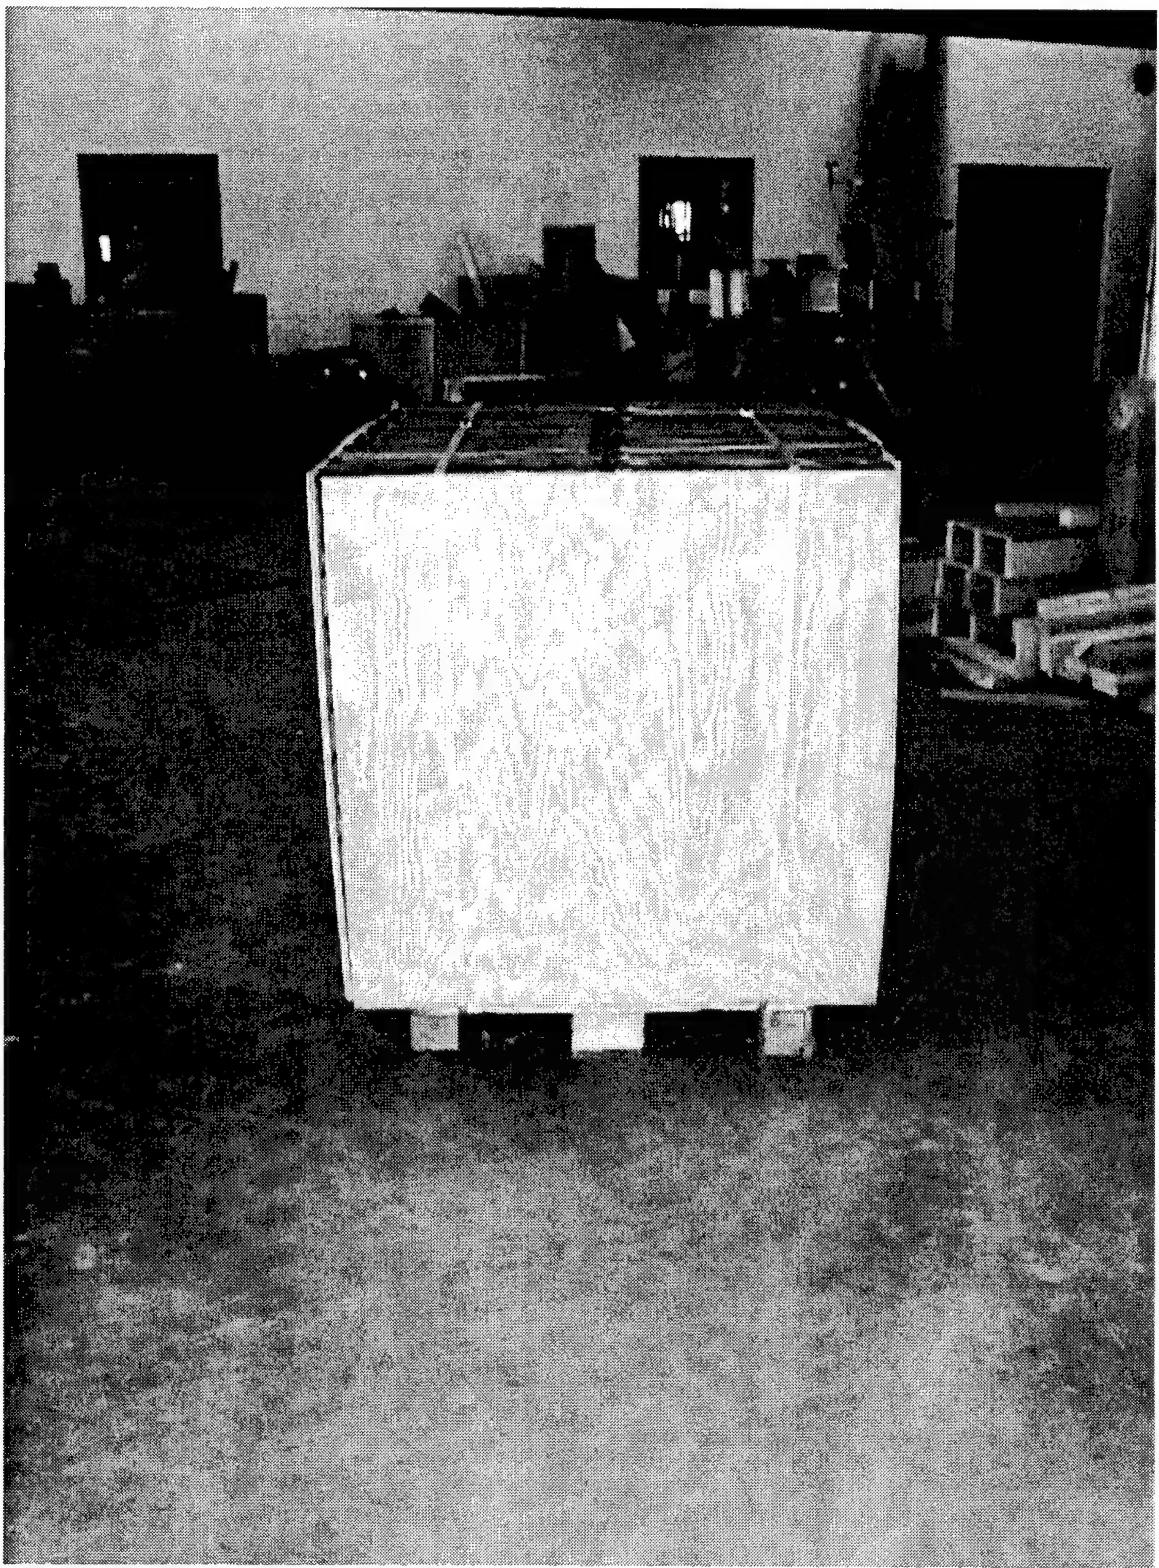
PHOTO NO. DAC-DEV-98-06-JOE1. This photograph shows a load of 3W (6,000 pounds) used during STANAG 2828 testing.
